Archaeological Site and Reservoir Shoreline Stabilization Using Wetland Plants and Bioengineering, Rice Reservoir, Wisconsin

by Cathy J. Wendt and Hollis H. Allen

PURPOSE. This technical note describes a case study in which wetland plants and bioengineering treatments were used to protect an archeological site on an eroded reservoir shoreline and to stabilize the shoreline from further erosion. The site is called the Robinson Site and is located on Rice Reservoir in northern Wisconsin, about 26 km (16 miles) southeast of Rhinelander.

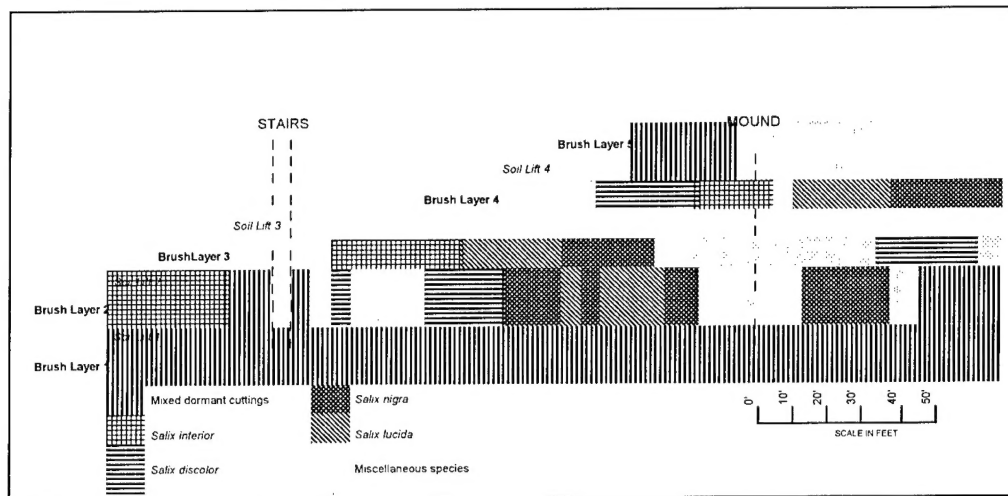
The transect method determined the survivability of the woody species by measuring 100 percent of the brush layers along transects. Survivability was determined by dividing the living stem occupation along the transect by the linear distance of materials originally planted. Each of the five layers was mapped (Figure 11) according to the species originally planted in the geogrid. Planting dates and harvesting dates were recorded. Portions of each brush layer consisted of different species (some were pre-grown in brush layer mats and some were installed as dormant cuttings). The species pre-grown in the brush layer mats were carefully monitored so valid comparisons between species could be made. The dormant cuttings were not differentiated by species but were intentionally mixed to increase the brush layer's chance of survival. Five

Figure 11. Diagram of brush locations in the geogrid

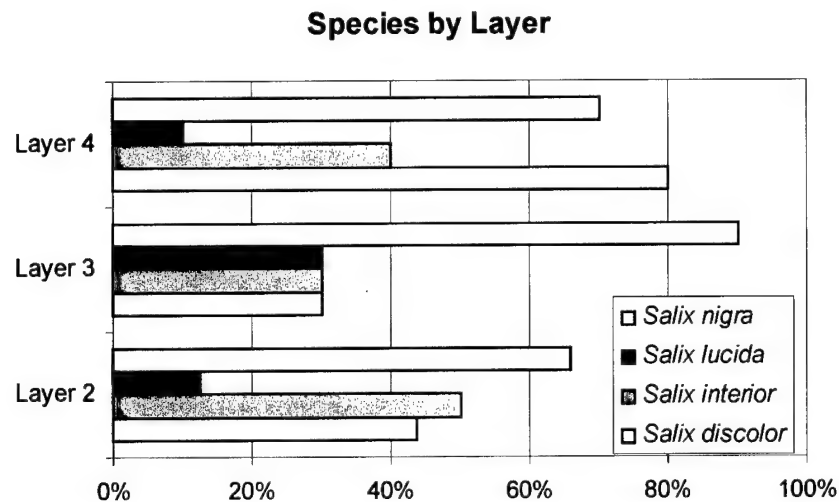
Of the 85 pre-grown brush layer mats, 73 contained the six native species. The placement of the mats on the bank was designed to test survivability of these species (Figure 12) under differing conditions within the site. *Cornus stolonifera* was not included in the comparison since an adequate amount of material could not be located. One native willow species, *Salix rigida*, performed poorly in the greenhouse and was also eliminated from the comparison. The 19 mats containing these two species plus 12 mats containing USFS stock are designated as miscellaneous species on the layout map (Figure 11) and were used to fill in the remaining areas among the four species being tested. The remaining four species demonstrated no apparent advantage or disadvantage to placement on the bank.

Figure 12. Plant survival by vegetative-geogrid height location by layer

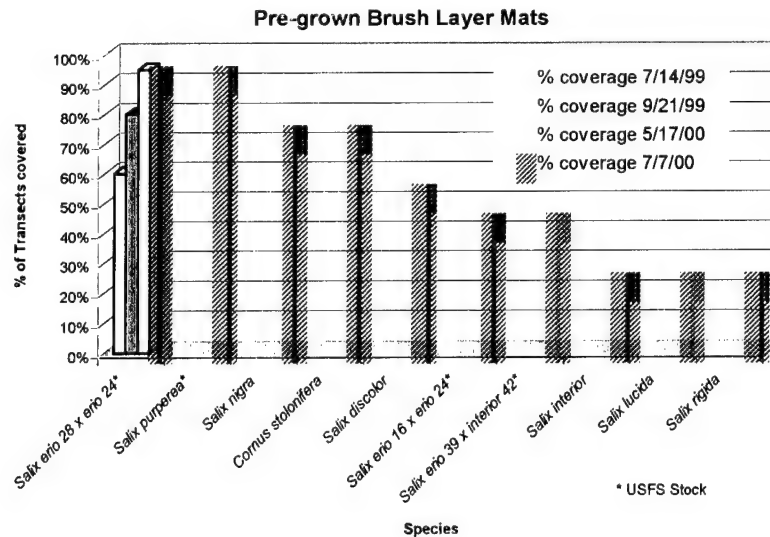
The transect method revealed a steady increase in the coverage for each pre-grown mat during the four testing periods from July 14, 1999 to July 7, 2000, with the exception of three mats (Figure 13). For one mat (*Cornus stolonifera*), coverage dropped by 20 percent between May 17, 2000 and July 7, 2000. The other mats were *Salix rigida*, which were already doing poorly in the greenhouse. Some mats showed increases as high as 60-80 percent, with an average increase of 23-percent coverage between July 14, 1999 and July 7, 2000. The species with the highest survival percentages were *Salix eriocephala* (90.0 percent) and *Salix purpurea* (90.1 percent) both from USFS stock. The native locally harvested species with the highest percentages were *Cornus stolonifera* (72.8 percent) and *Salix nigra* (72.7 percent). *Salix lucida* and *Salix rigida* had the lowest survival (17.7 and 16.5 percent, respectively). The overall survival rate of all pre-grown brush layer mats was 46.2 percent.

Figure 13. Performance (percent coverage) of brush layer mats by species

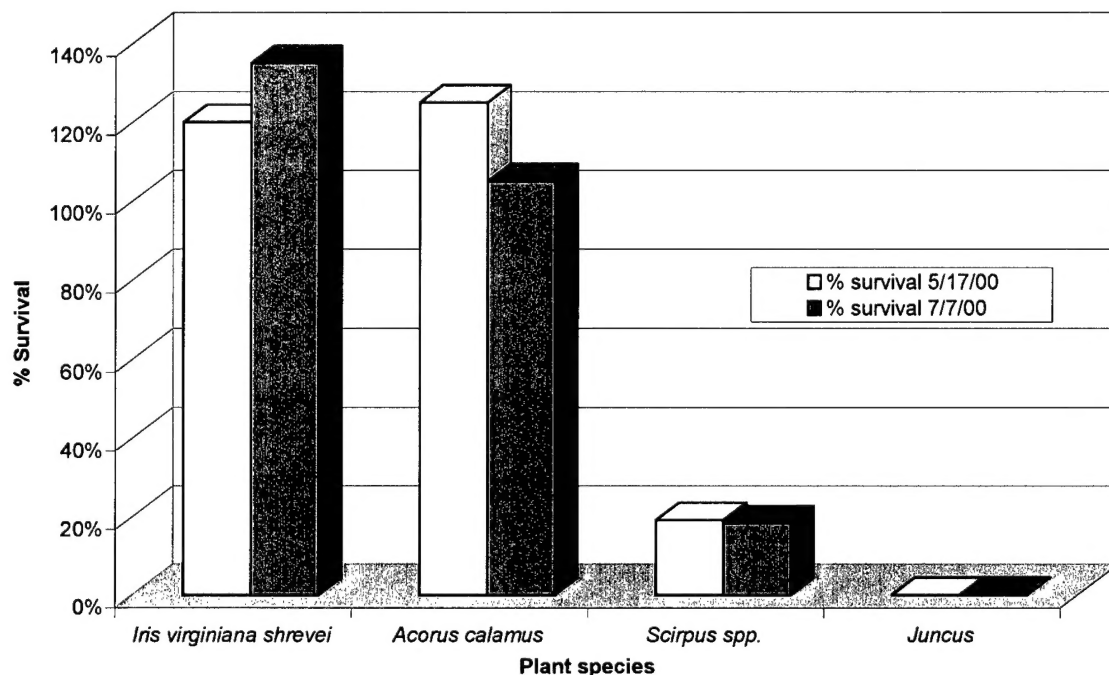
Of the planted species, *Iris versicolor* and *Acorus calamus* had the highest survival percentages when measured on July 7, 2000 (135 percent and 105 percent, respectively) indicating they have already regenerated. *Scirpus spp.* have not fared as well, having a combined survival percentage on July 7, 2000 of 18 percent. Of the 60 *Juncus* that were planted, none survived (Figure 15).

Figure 15. Survival of plants behind the branchbox breakwater
